Confidential Inspection Report

LOCATED AT:
1234 Sample
Omaha, Nebraska 68000

INSPECTED ON:
Monday, October 22, 2018

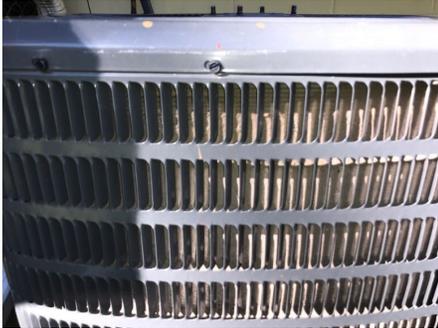
This unit needs to be cleaned and serviced by a licensed HVAC tech. The coils are fun of tree debris which will dramatically reduce the effective life of the unit.

The condensing unit appears to be properly installed and in serviceable condition with the exception of items noted below.

This unit needs to be cleaned and serviced by a licensed HVAC tech. The coils are full of tree debris which will dramatically reduce the effective life of the unit.

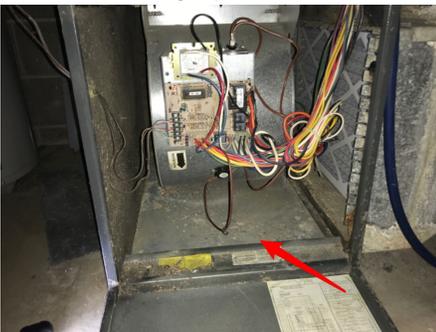
Dust and debris have built up on the blower and in the blower compartment. We recommend servicing and inspecting by a licensed HVAC tech.

Needs cleaning

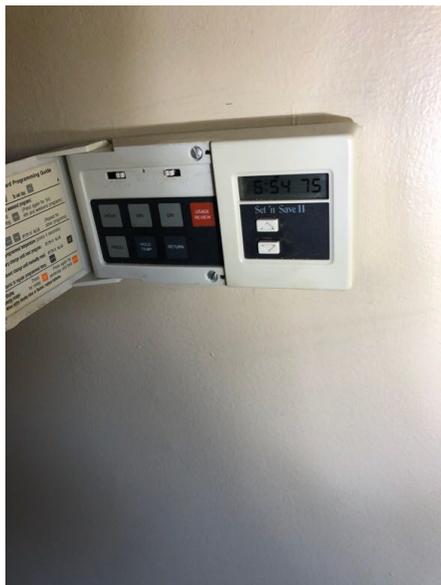
The thermostat is generally functioning but the buttons stick making it hard to program. It may be more efficient with a newer thermostat.

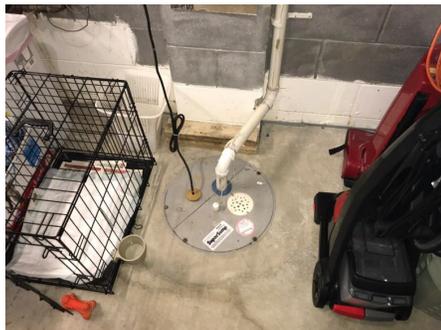
The sump pump/sewage ejector electrical is improper and/or hazardous. We recommend further review by a licensed electrical contractor.

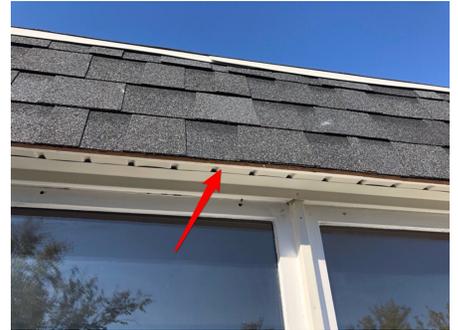
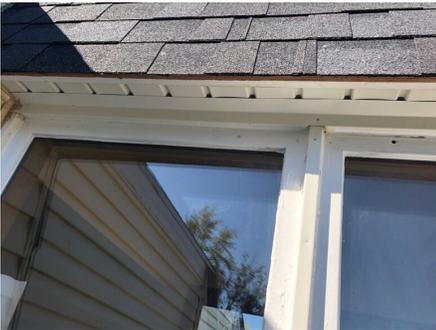
There is missing flashing where the windows meet the roof material. Currently this is exposed wood which is an area of concern due to moisture entry.

No flashing

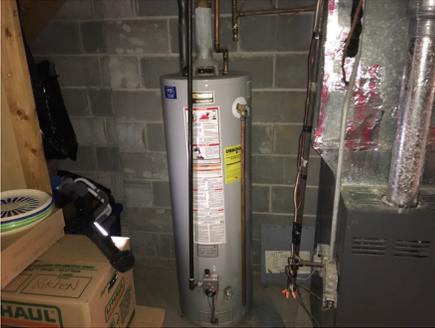
This water heater is beyond its expected service life. Although it is still operating, the need for replacement should be expected in the near future. Most water heaters has an expected life of 10-12 years. This unit is 20 years old therefore it is required to be labeled near end of its useful life even though it is currently functioning.

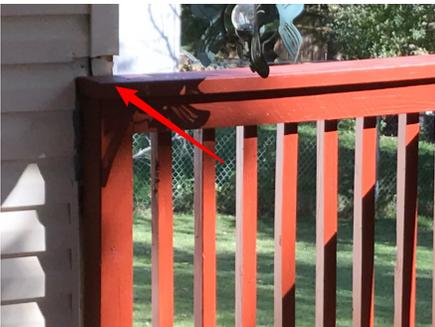
The vinyl siding appears to be properly installed and generally in serviceable condition, with exceptions noted below. Dirty with some small movement in the vinyl. Some pieces missing where deck is attached.

Missing siding

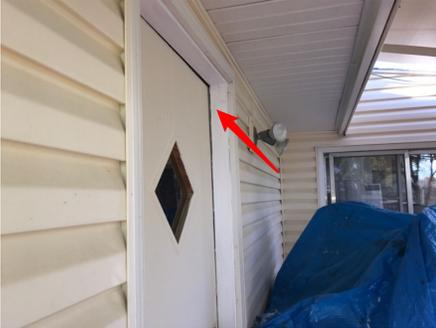
Door needs adjustments

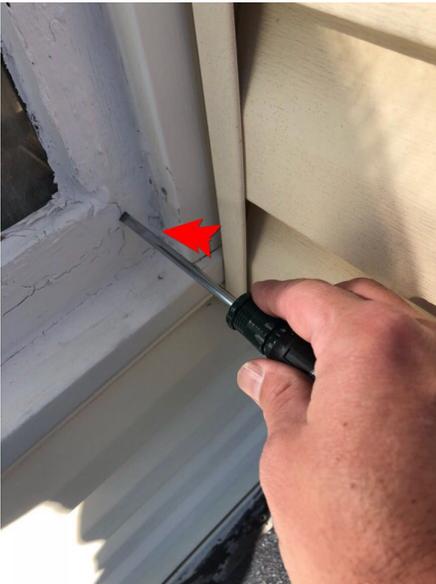
5: - Several windows are deteriorated. We recommend they be detailed, repaired and/or replaced. The 8 upstairs windows to the right when you go up the stairs that overlook the lower level show the most signs of deterioration, however many of the wood windows should show similar deterioration.

Several windows are deteriorated. We recommend they be detailed, repaired and/or replaced. The 8 upstairs windows to the right when you go up the stairs that overlook the lower level show the most signs of deterioration, however many of the wood windows should show similar deterioration.

Rotten

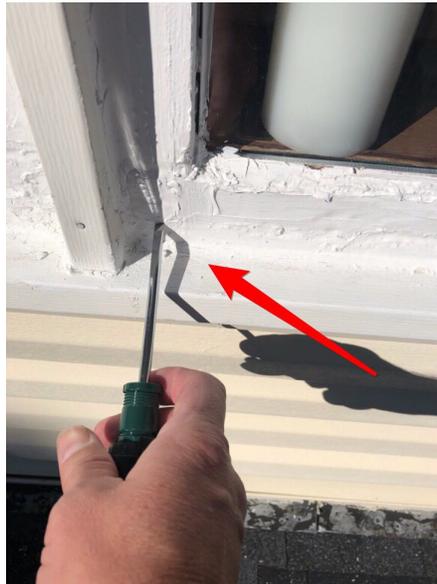
Rotten

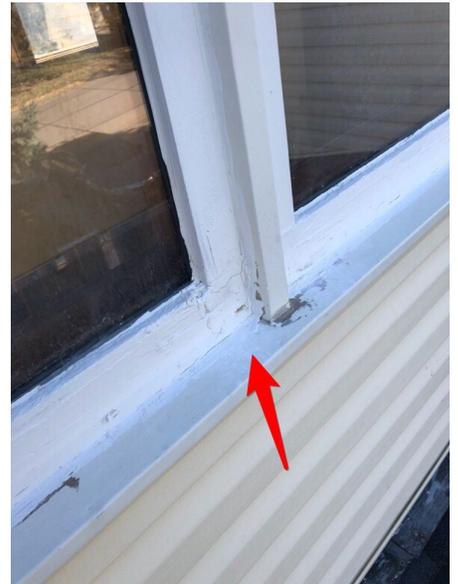
Caulk and paint on rotten windows

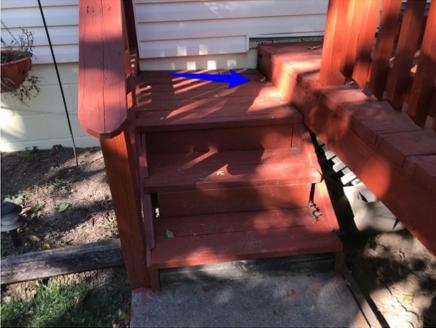
Slight pitching from left to right as you look at the stairs

Stair pitch

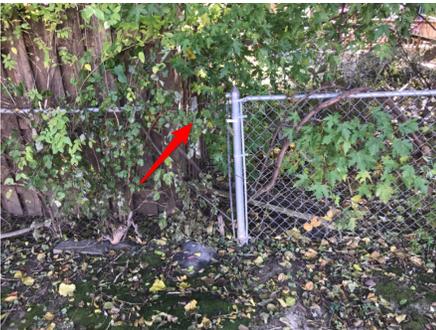
Fence rail missing

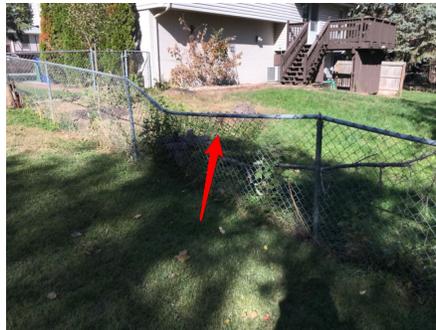
Bent fencing

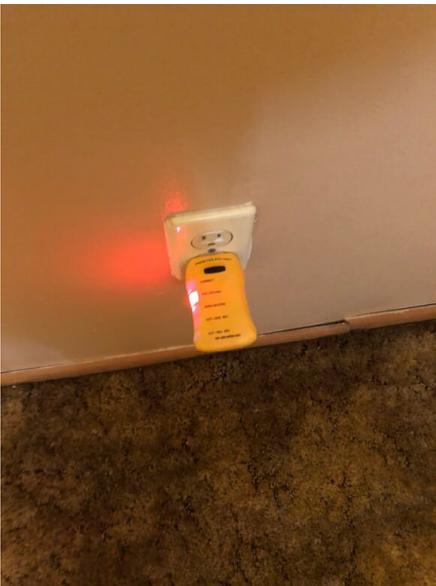
7: - The receptacle is an ungrounded three prong type. To provide an increased margin of safety, we recommend either the receptacle be repaired and grounded or equivalently protected by adding a GFCI receptacle.

The receptacle is an ungrounded three prong type. To provide an increased margin of safety, we recommend either the receptacle be repaired and grounded or equivalently protected by adding a GFCI receptacle.

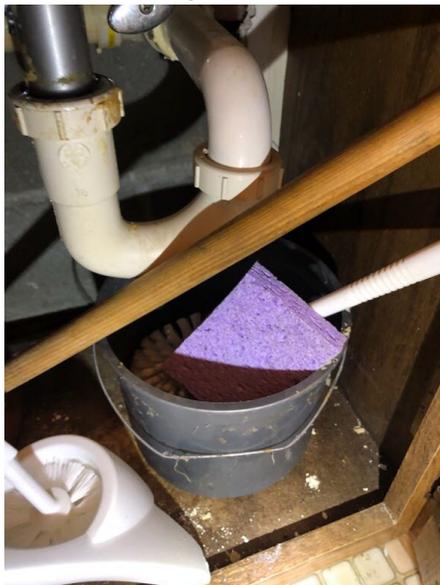
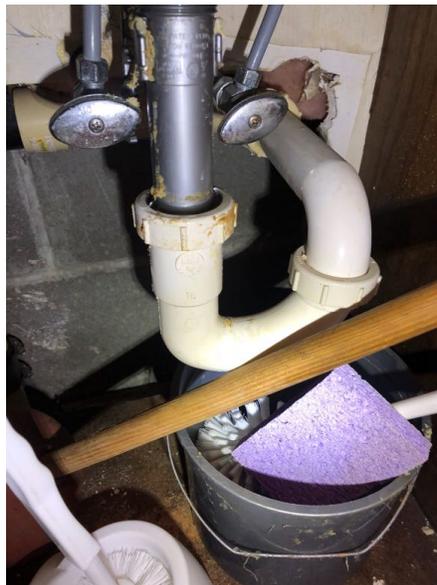
8: - The drain is slow in the basement bathroom sink. We recommend the trap be cleaned of grease, hair, sludge, etc. and if this does not correct the problem, we recommend the line be 'snaked' by a professional sewer cleaning service. The trap also leaks

The drain pipe fitting is leaking. We recommend it be repaired or replaced.

The drain is slow in the basement bathroom sink. We recommend the trap be cleaned of grease, hair, sludge, etc. and if this does not correct the problem, we recommend the line be 'snaked' by a professional sewer cleaning service. The trap also leaks

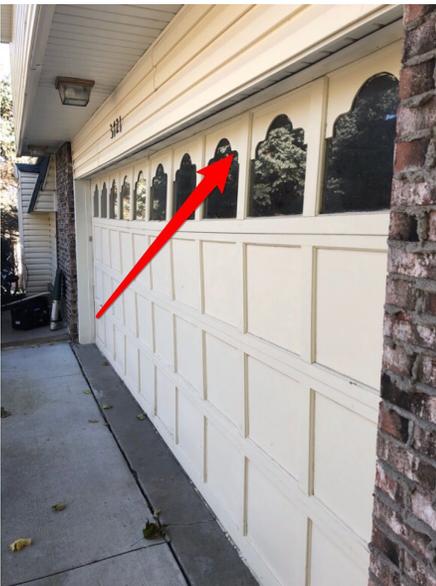
The door doesn't seal and appears to need adjustments

Door doesn't close and seal

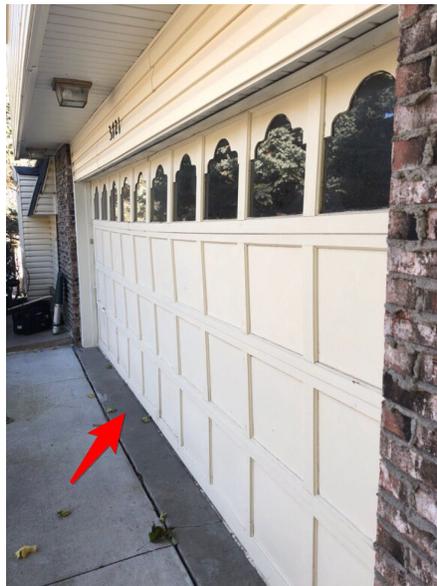
The door has signs of rot on the lower portions inside and out. It appears an additional support has been added to the lower interior portion of the garage door to support it.

Rot near lower portions of door

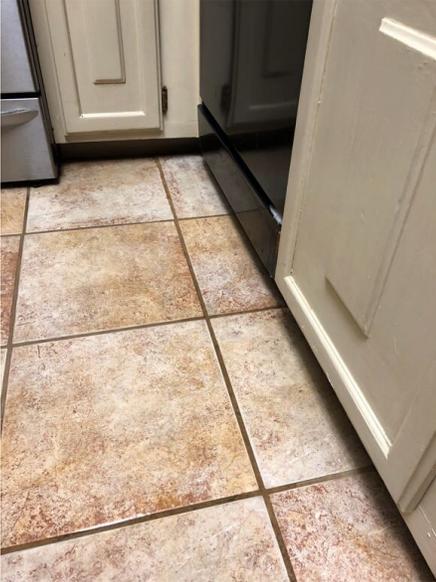
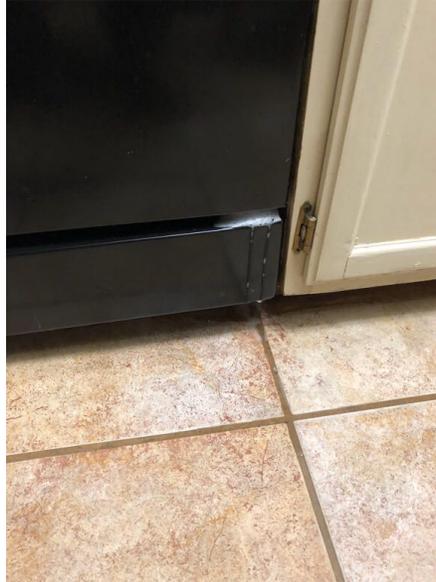
The dishwasher is leaking around the door. We recommend this condition be repaired before damage to the floor results. Water was leaking all the way to the dining room.
