123 Elite Drive Omaha, NE

Inspection Date: February 26, 2018 @ 11am

Inspected By: Aaron Whaley – Owner Elite Inspection Services, LLC

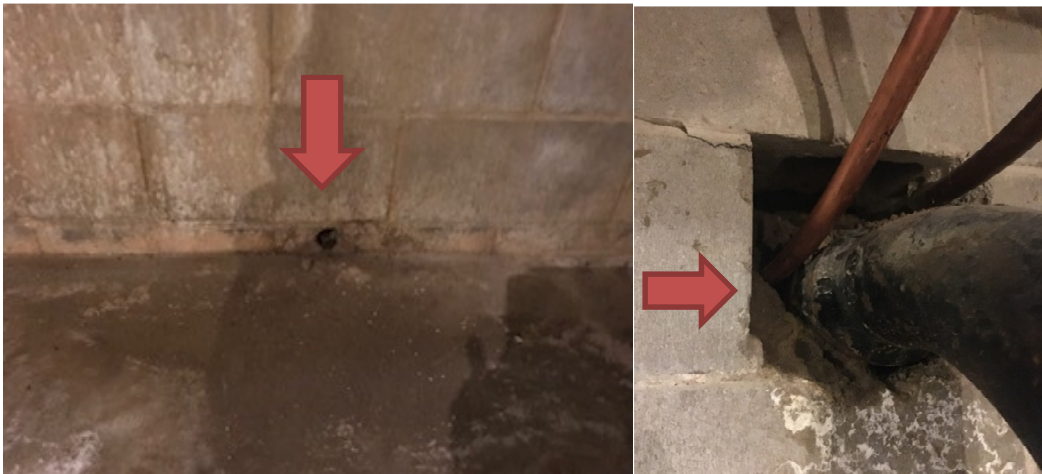
The visible foundation is performing as intended. There are no visible cracks of any significance and no signs of significant differential movement. Forecasting future performance is impossible because heavy rainfall, drought and other unpredictable soil conditions can produce foundation movement. There were to visible holes that appeared to be manmade that should be filled to prevent future cracks or foundation movement. This should be addressed as an action item.

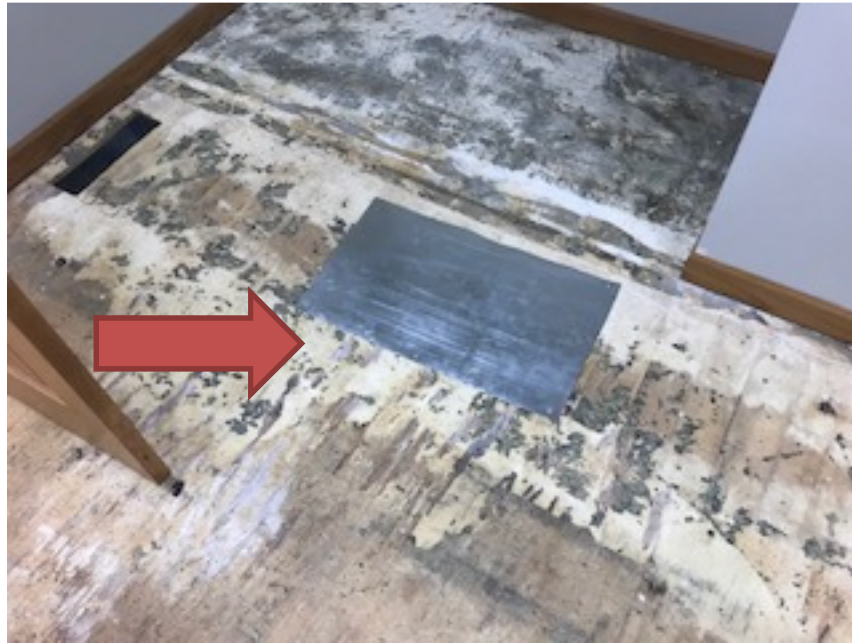
The concrete floors were in the North 2/3 of the building that didn't have the basement under it. The south 1/3 of the building had wooden subfloor that appeared to be in mostly acceptable condition. There was an office that appears to have had a floor vent moved and instead of filling the hole from the old vent with plywood it was just patched with a piece of flashing metal. This is not an acceptable way to fill a hole as it does not provide the proper support to the floor and could be a safety hazard. **This should be addressed as an action item.**

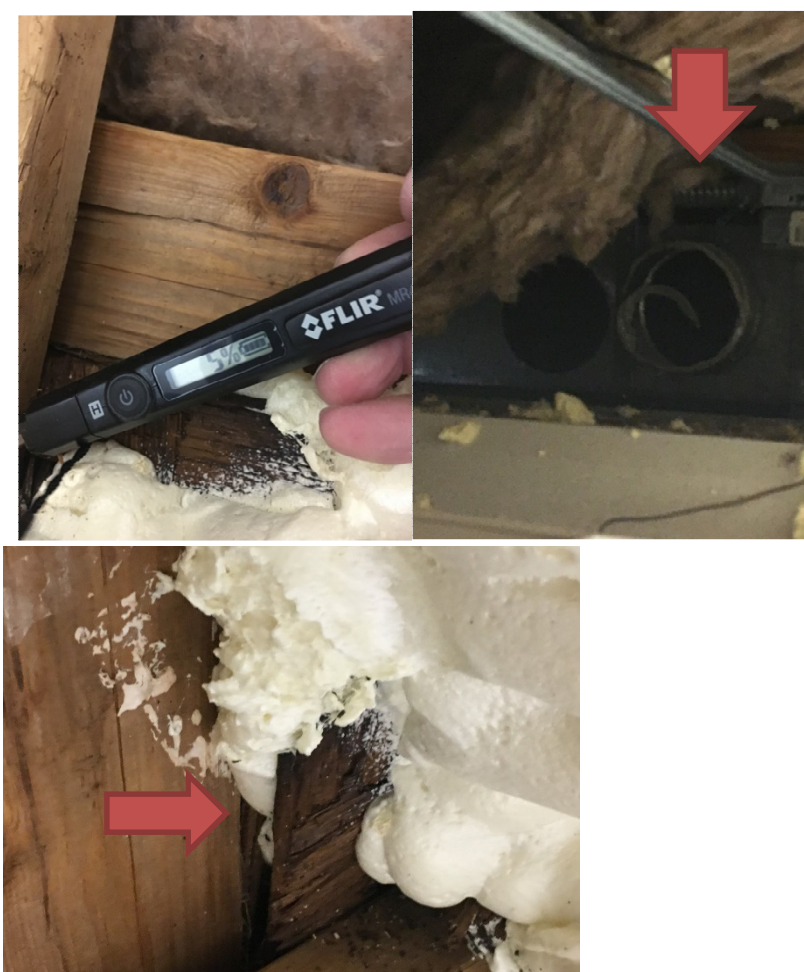
There roof structure was viewed at random however the entire perimeter of the building between the top of the brick wall and the roof deck was filled with spray foam. Because of the spray foam insulation we were not able to view all the way to the wall however there were locations with signs of current or previous moisture damage. There was also an air duct distribution box that did not have vent leads running from this or the outflow ends capped. **This should be reviewed by a licensed HVAC expert as an action item.**

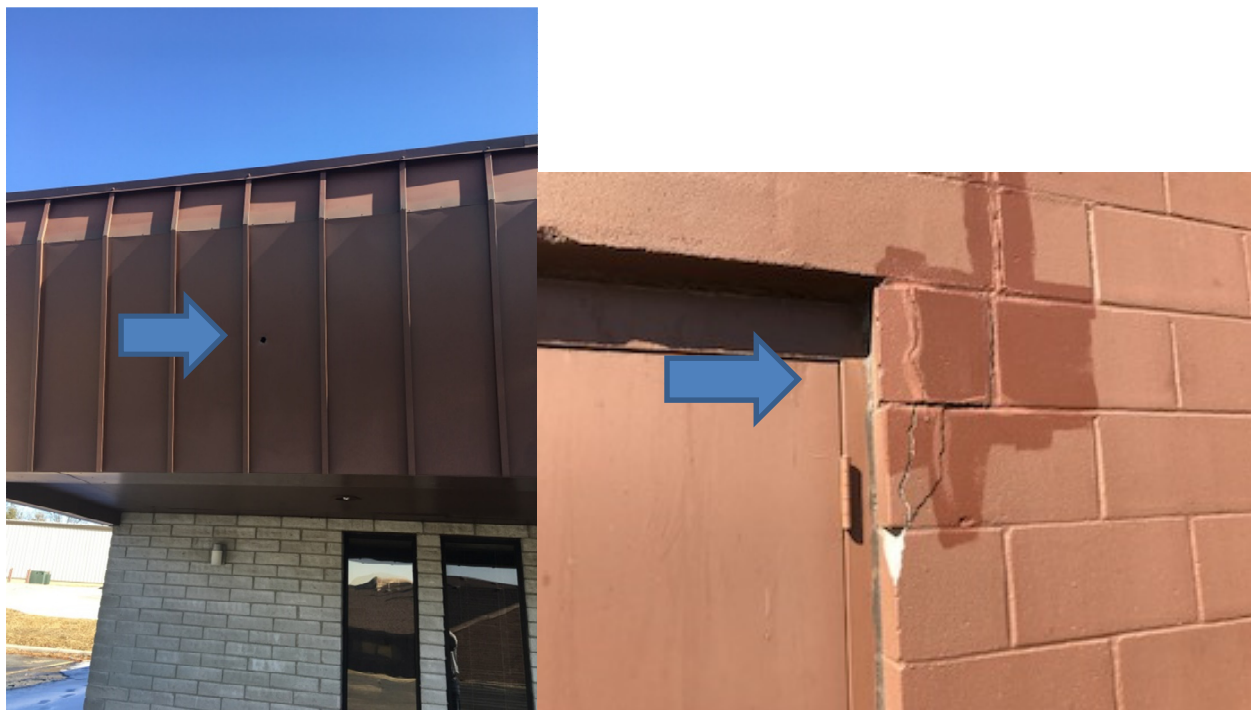
The exterior was of white brick with a painted stone block in the rear of the building. The building has a covered overhang that was clad in steel. There was a hole noted in the overhang that could be a possible entry point for birds or rodents. The rear block wall next to the rear fire door had some visible cracking. This cracking was notice only in this section of the wall. It would be recommended to have a licensed professional investigate this area for potential structural issues. Signage areas were noted but not tested.

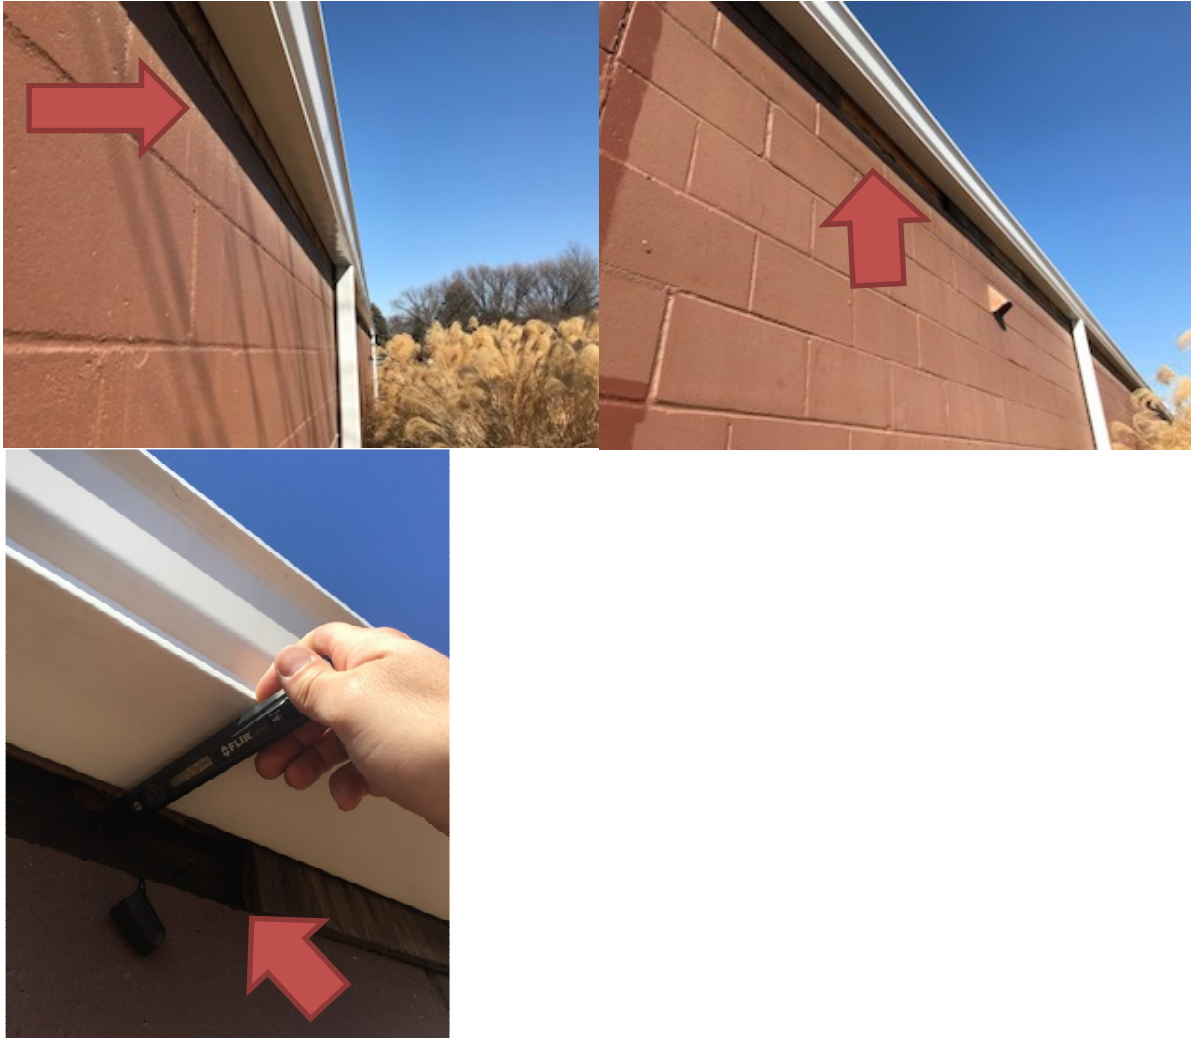
The front of this building has a steel faced overhang/walkway with painted plywood soffits/roof that has standard can lighting to illuminate the walkway. This all appeared to be in functional condition with the lights operating on a timer located in the basement of the building. The rear of the building between the block foundation walls and the flat roof was exposed or missing plywood that showed past water damage. Exposed plywood is always a concern. Given the proximity to the gutters on the building and the fact the buildings entire roof drains towards

this exposed plywood it is recommended that this entire area be flashed. There were also sections that were missing which provide direct access to the interior of the building from birds or rodents. **This is an Action item and should be addressed by a licensed professional.**

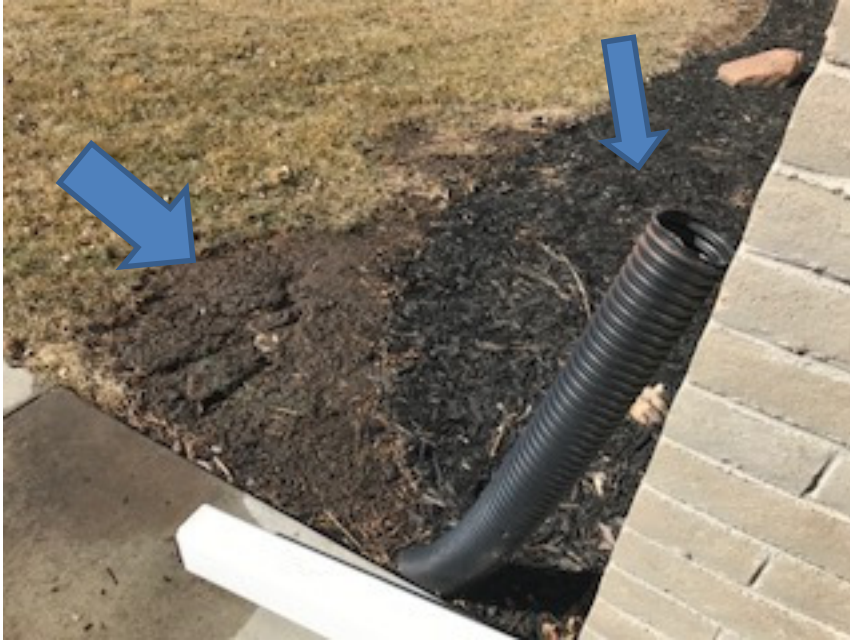
The drainage on this building should be from the front of the building to the back of the building where the gutters are located. There is a black would be drain pipe coming out of the ground. The functionality of this pipe is not known and should be investigated. Downspouts are located on the North and South Ends of the buildings. Both downspouts need extensions. This is a consideration item.

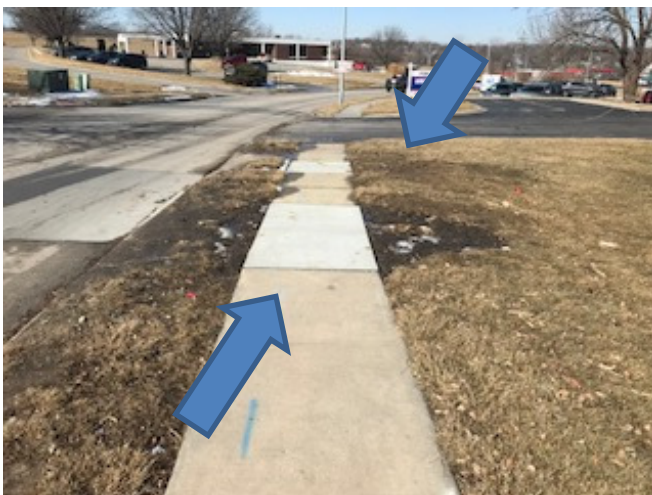
The exterior landscaping was generally along the South side of the building. There appeared to be recent underground work done as evident from new sidewalk slabs and disturbed soil. [It is unclear what work was done](#) however you may want to inquire with the seller regarding that work to confirm that further investigation from a licensed professional isn't needed. This is a consideration item.

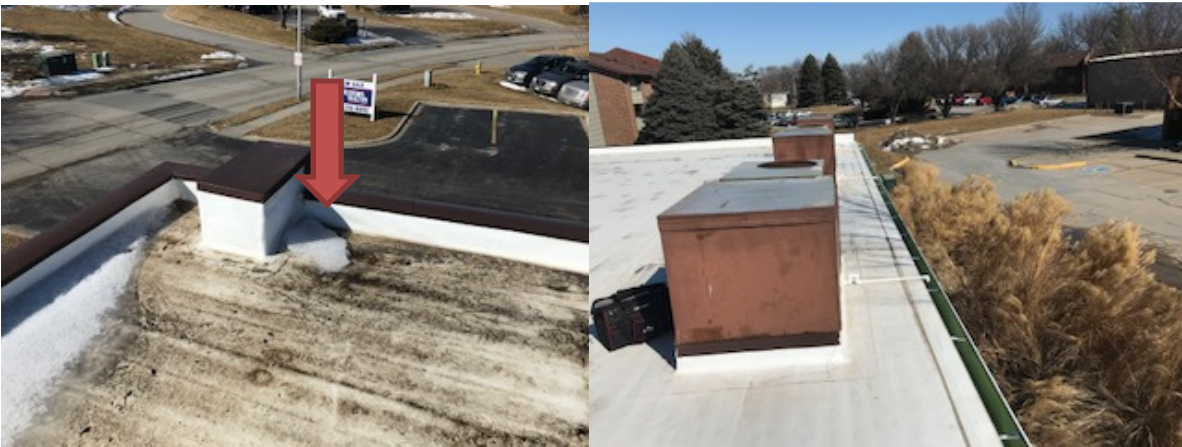
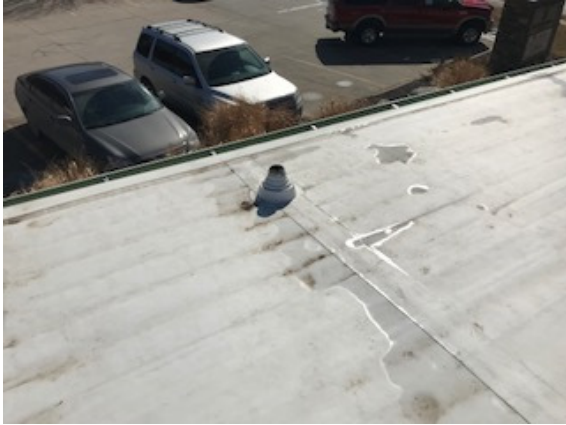
The roof material appeared to be a new rubber membrane type roof with overlapped seams that roll to the drains. The roof appeared to have standing water in the Northwest and Southwest corners of the building. It appeared that the roof pitch in certain areas was pitched towards those locations instead of where the gutters were along the back of the building. Standing water is never ideal and always a concern especially in a corner location that has a large number of roof seams. **This should be investigated by a licensed professional and is considered an action item.** Video of this area will be attached to the report but cannot be inserted in the report directly.

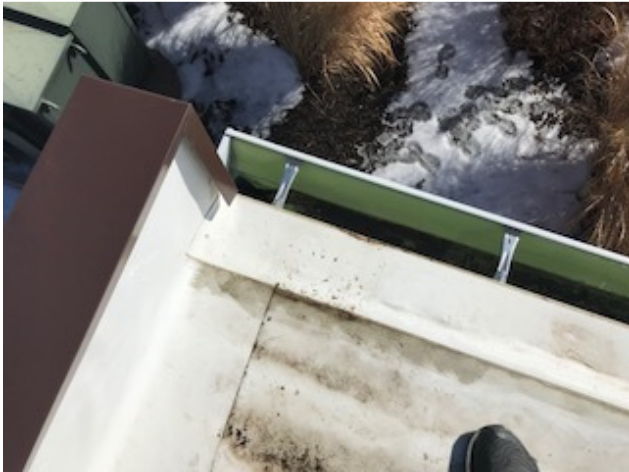
The drains on this roof appear to be new and are tied into the roof membrane system appropriately. Downspout pipe extensions should be added as mentioned earlier in the report.

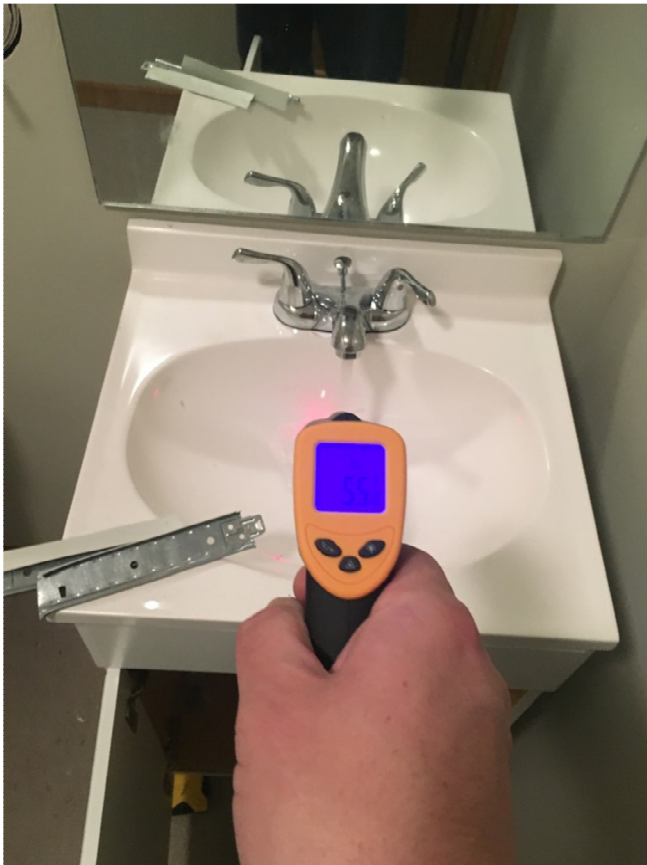
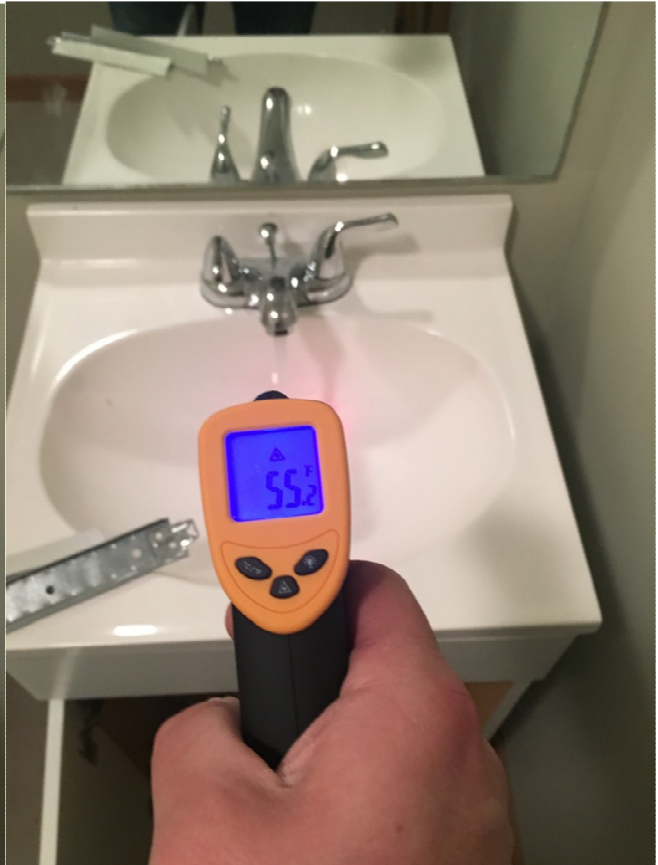
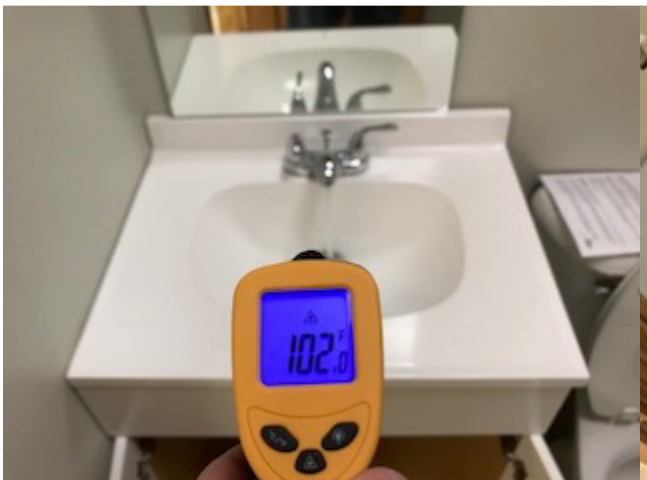
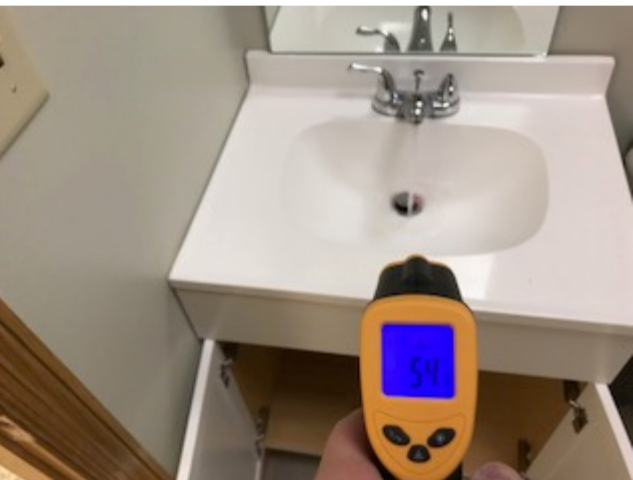
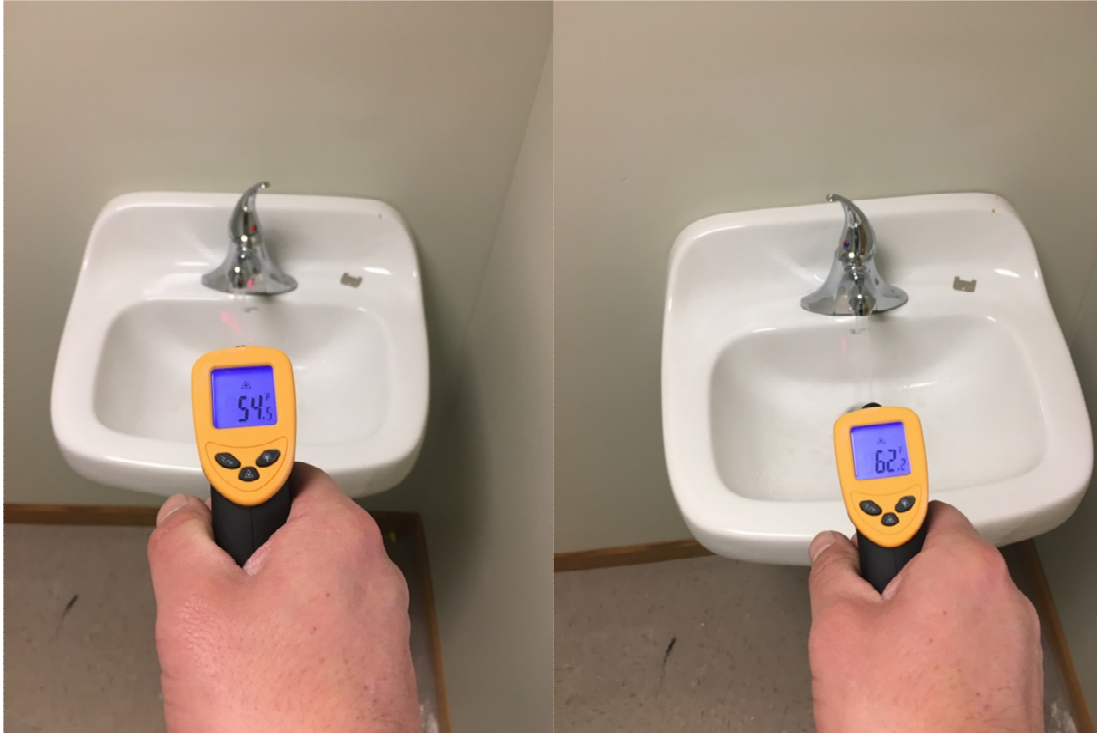
The water was functioning in the building. Water was tested at all existing bathrooms for hot and cold water as well as for functionality of toilets. There was also 1 kitchen sink tested. The sinks located on the North side of the building would work but the temperature readings were the same on both hot and cold. The sinks on the South half of the building were functioning properly hot and cold. Photos below are a sampling of the sinks. Remaining

photos will be included in the photo addendum at the end of this report. All faucets with similar hot and cold readings were run for approximately 3-5 minutes to ensure ample time for hot water to get to the faucet. This water issue should be reviewed by a licensed plumber and is considered an Action Item.

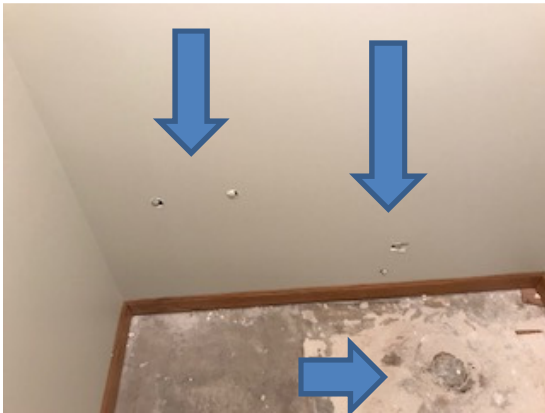
There was 1 toilet drain that was filled with concrete however the plumbing supply lines were still in place if it was ever to be turned back into a toilet area that drain line would need to be checked by a licensed plumber. [This is a Consideration Item](#)

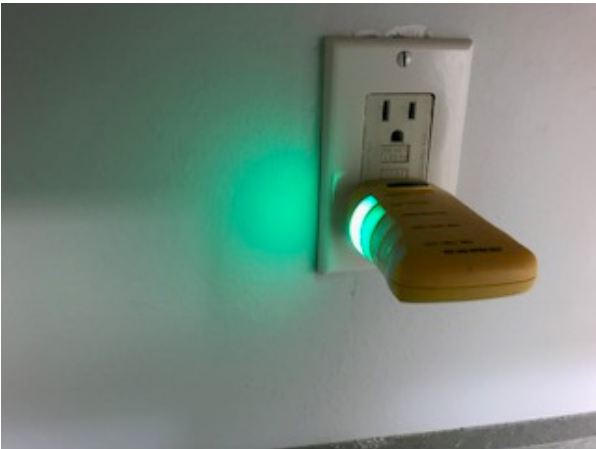
All Electrical outlets tested appeared to be in good operational condition. Outlets were tested randomly with not every outlet tested. There were 2 mystery switches found. The first was located in what appears to be a former bathroom now storage/server room. The other mystery switch is located in the office that had the metal flashing over a hole. [Mystery switches are a consideration item that you may want to have reviewed by a licensed electrician.](#)

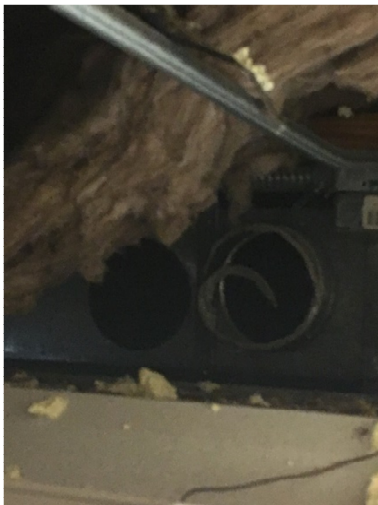
The distribution system looks in typical repair. Not every section of the ductwork was inspected. As previously noted above one distribution branch did not have ducts attached to it and the holes were not sealed.

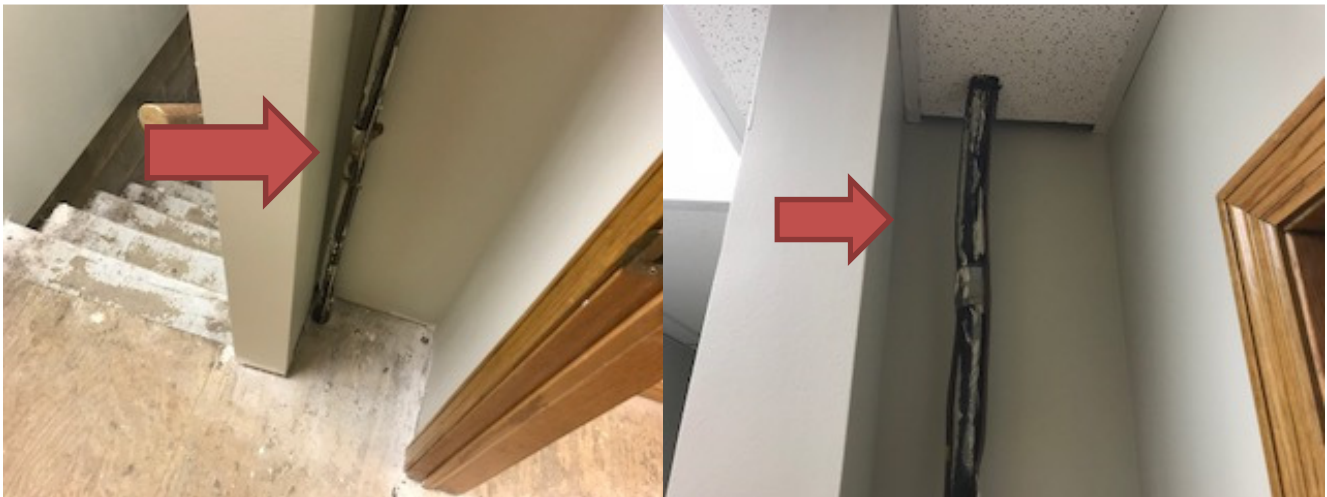
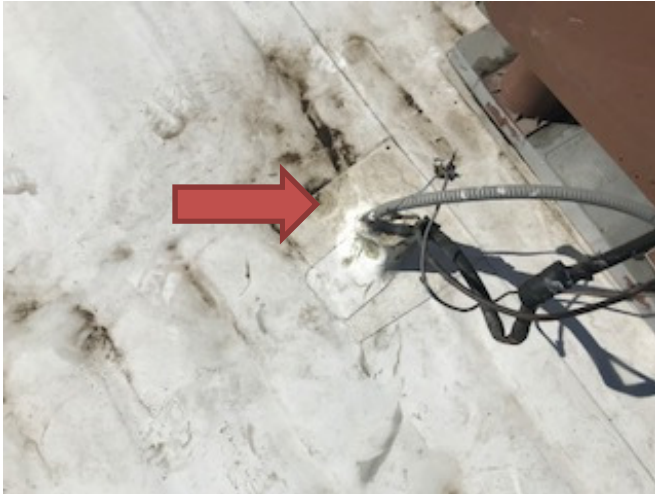
Piping for the split unit on the south side of the building was run down using a vent collar and is a potential safety concern. This coolant filled pipe runs down a next to the corner of the basement steps and could potentially be hit or nicked causing a coolant leak. The fact that this set of pipes was run through a vent collar and then caulked to seal is not acceptable and subject to a leak. **It is recommended that a licensed professional review how these pipes are transferred from the roof to the basement as well as cover or enclose this pipe inside the office to eliminate the chance of damage to the pipe or a person in the event of a leak. This is an Action item.**

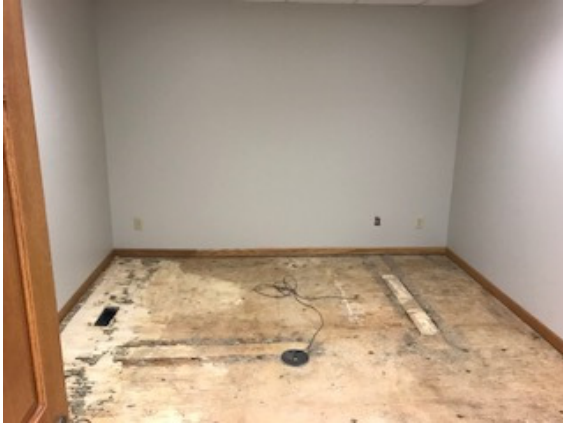
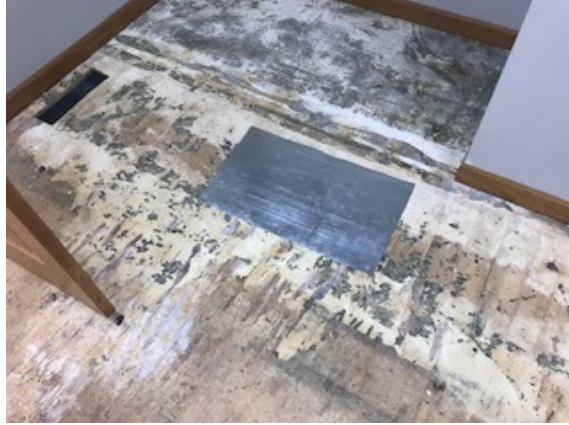
The entire office was without carpet. The areas of the office that used a subfloor were missing vent registers throughout. These were not visually present but may be in the office due to the flooring surfaces being removed. The walls were in reasonably good shape with only minor wear and tear marks.

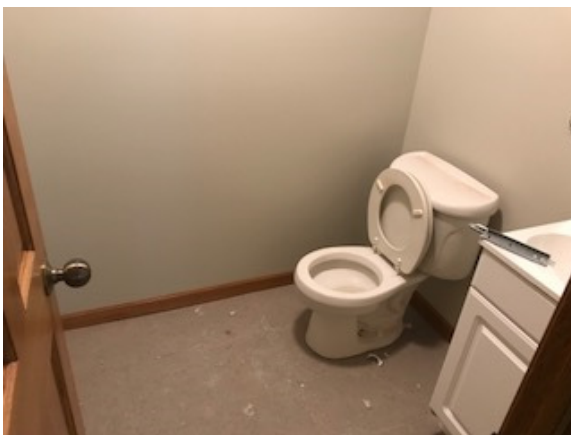
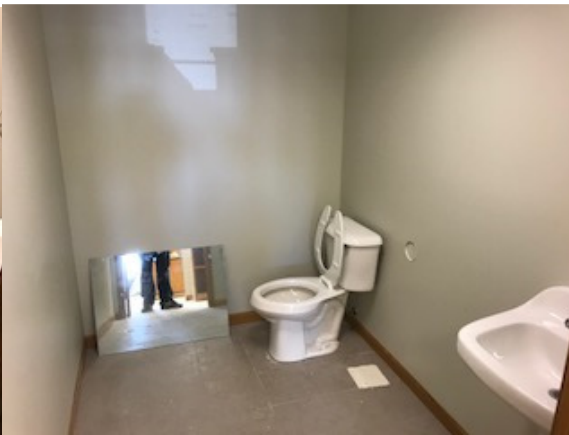
All restrooms inspected had vinyl flooring with a toilet and a sink. As noted in the plumbing section above a portion of the bathrooms hot water fixtures were not working appropriately. **As noted above this is an Action item.**
