Confidential Inspection Report

LOCATED AT:
1234 Sample
Omaha, Nebraska 68000

INSPECTED ON:
Monday, October 22, 2018

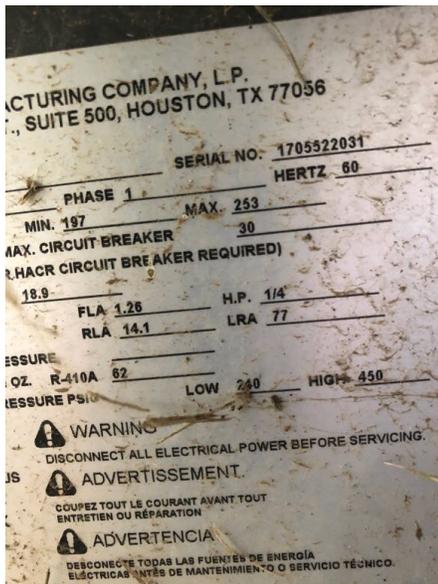
Estimated to be approximately 2 years old.

Manufacturer: Goodman

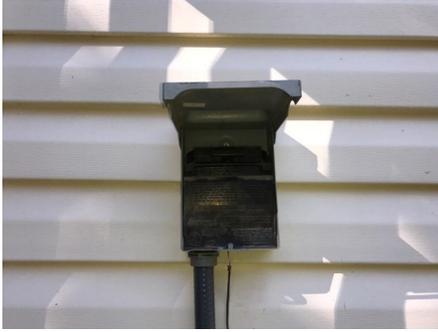
HVAC WIRING

All accessible wiring appears in good condition.

The HVAC equipment appears to be properly bonded to ground.

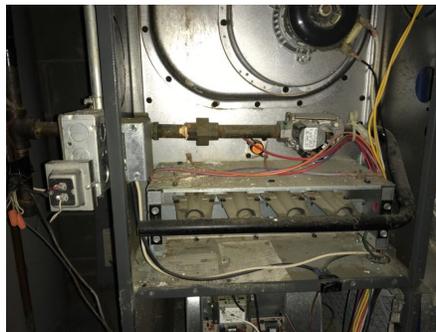
Needs cleaning

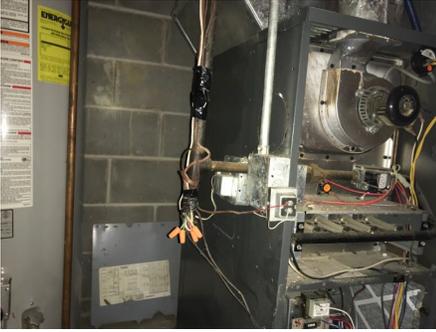
GENERAL COMMENT

The heating is near the end of its expected service life. Although it responded to normal operating controls, the need for replacement should be expected within the next few years. Useful life may be extended with proper service. There have been no service records left on this furnace since it was installed.

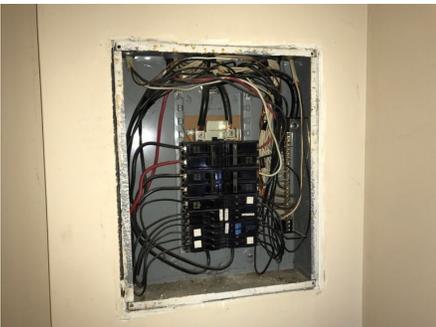
MAIN DISCONNECT

There is no main electrical service disconnect. See comments below under 'Main Disconnect'.

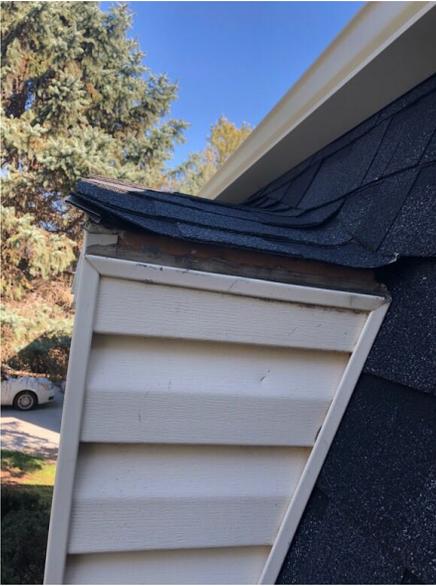
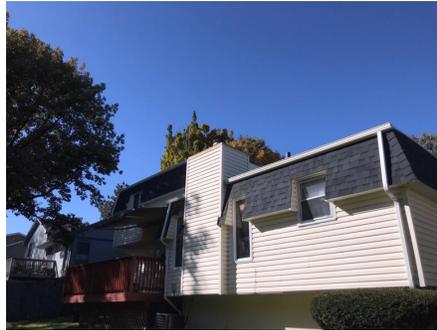
There is missing flashing where the windows meet the roof material. Currently this is exposed wood which is an area of concern due to moisture entry.

No flashing

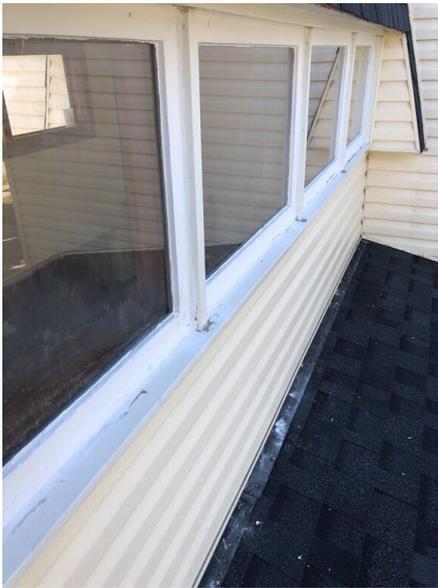
Caulk and paint on rotten windows

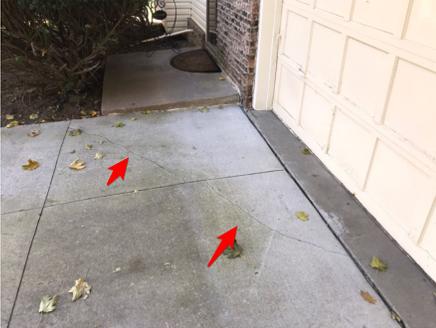
Minor cracks

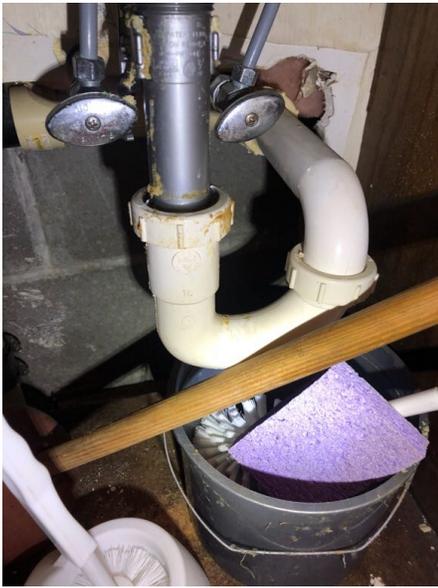
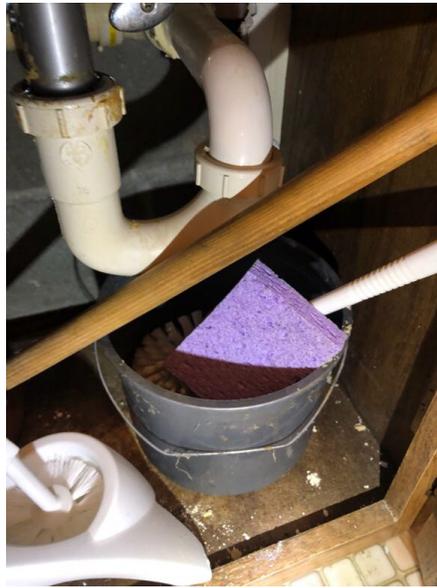
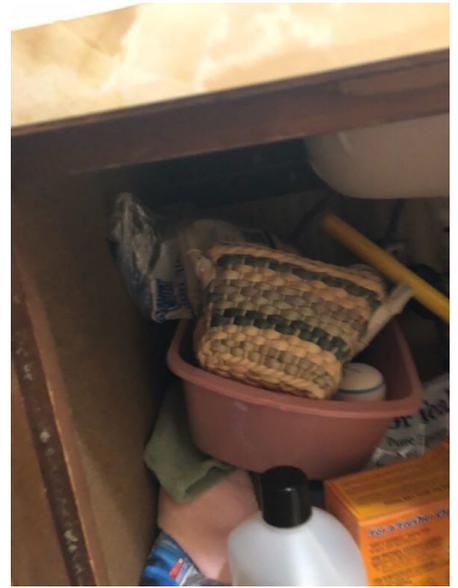
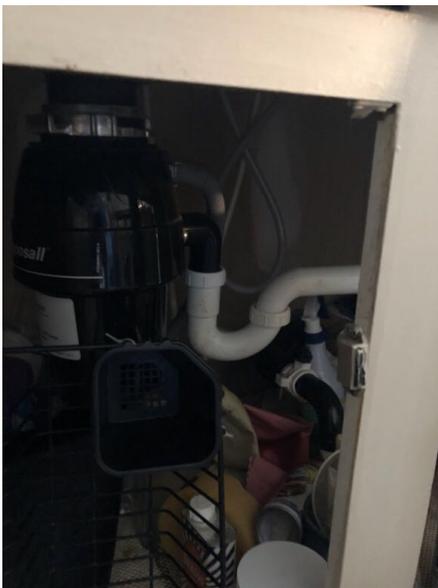
The drain pipe fitting is leaking. We recommend it be repaired or replaced.

The drain is slow in the basement bathroom sink. We recommend the trap be cleaned of grease, hair, sludge, etc. and if this does not correct the problem, we recommend the line be 'snaked' by a professional sewer cleaning service. The trap also leaks

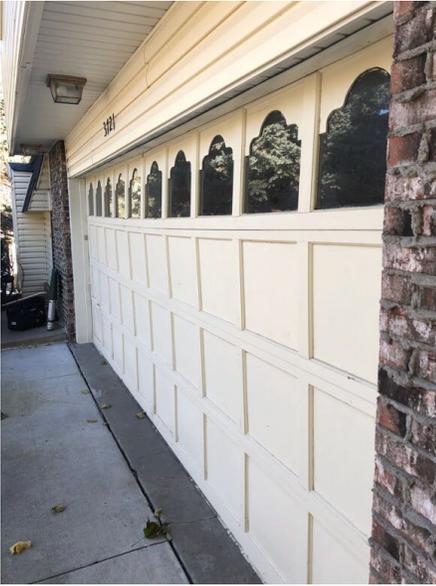
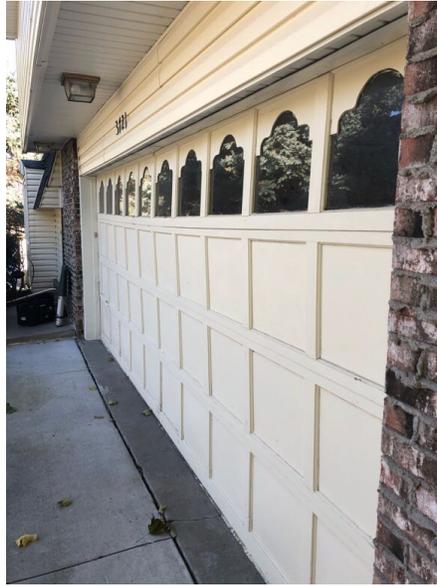
Rot near lower portions of door

The garage door appears to be properly installed, with exceptions noted below.

The door has signs of rot on the lower portions inside and out. It appears an additional support has been added to the lower interior portion of the garage door to support it.

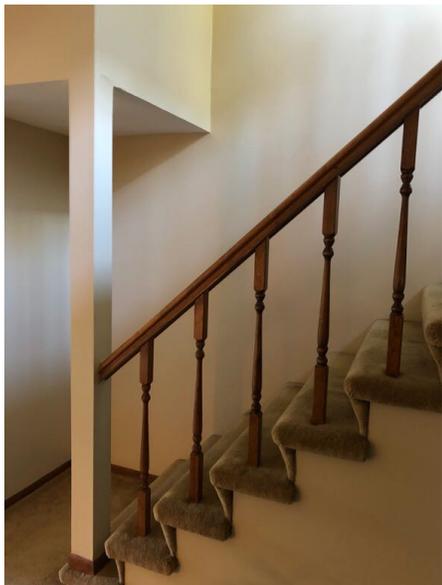
RAILING

The railings appear to properly installed and are in serviceable condition.

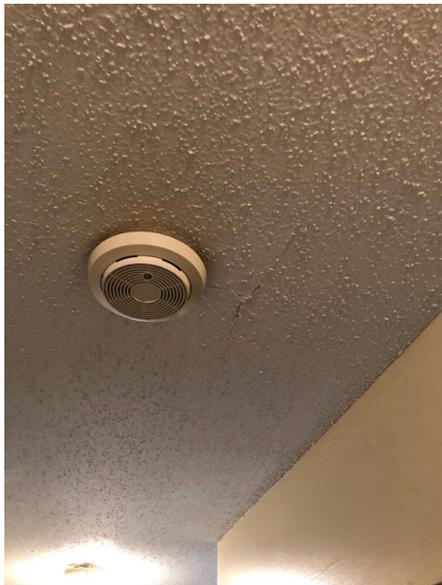
GENERAL COMMENT

The finished surfaces, hardware, windows, and doors were found to be generally in good condition at the time of our inspection. However, this area is in need of routine maintenance as noted above or in other sections of this report.

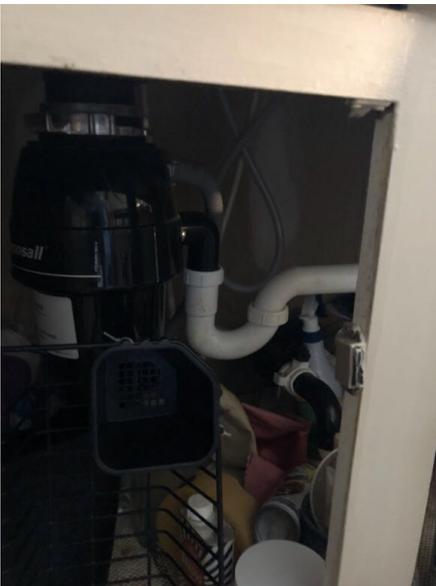
AIR GAP

The dishwasher drain is equipped with an air-gap fitting (the cylinder protruding above the sink). This assures separation of the supply water from the waste water.

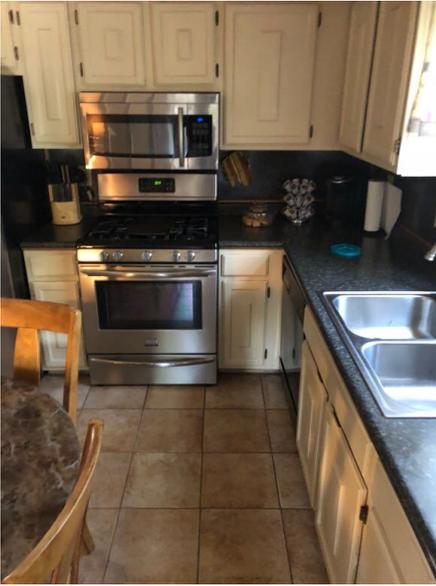
SINK

There is a double sink.

The sink appears to be properly installed. When operated, it was observed to be fully functional and in serviceable condition.

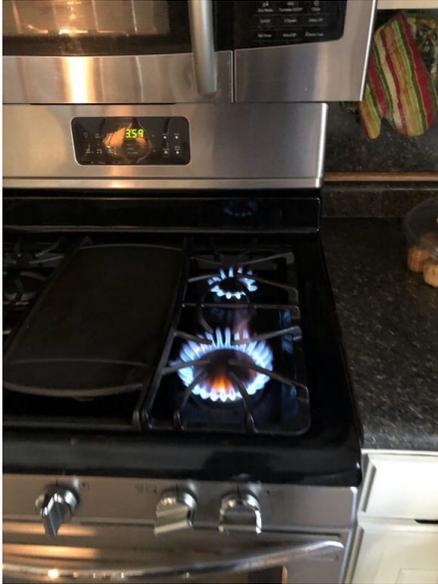
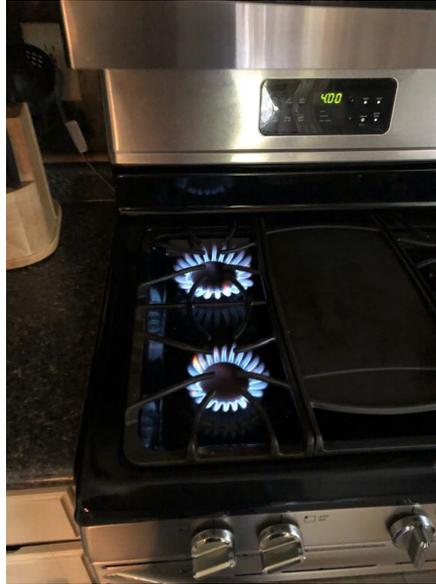
OVEN

The oven was turned on with the normal operating controls and found to be in satisfactory working condition.

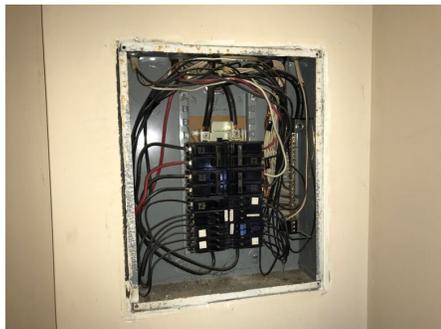
MAIN DISCONNECT
ELECTRICAL SYSTEM

There is no main electrical service disconnect. See comments below under 'Main Disconnect'.

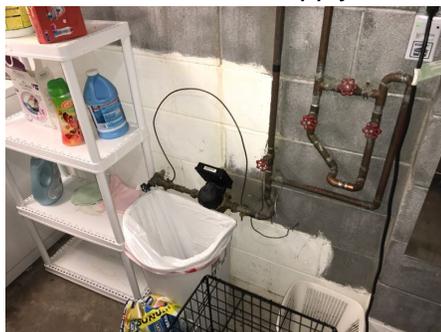
SEWER CLEANOUT
PLUMBING

The sewer cleanout is located in the basement. Behind furnace
